Final Bathymetric Survey for Armor Stone Layer

PREPARED FOR: de maximis, inc.

PREPARED BY: CH2M HILL

DATE: May 8, 2014

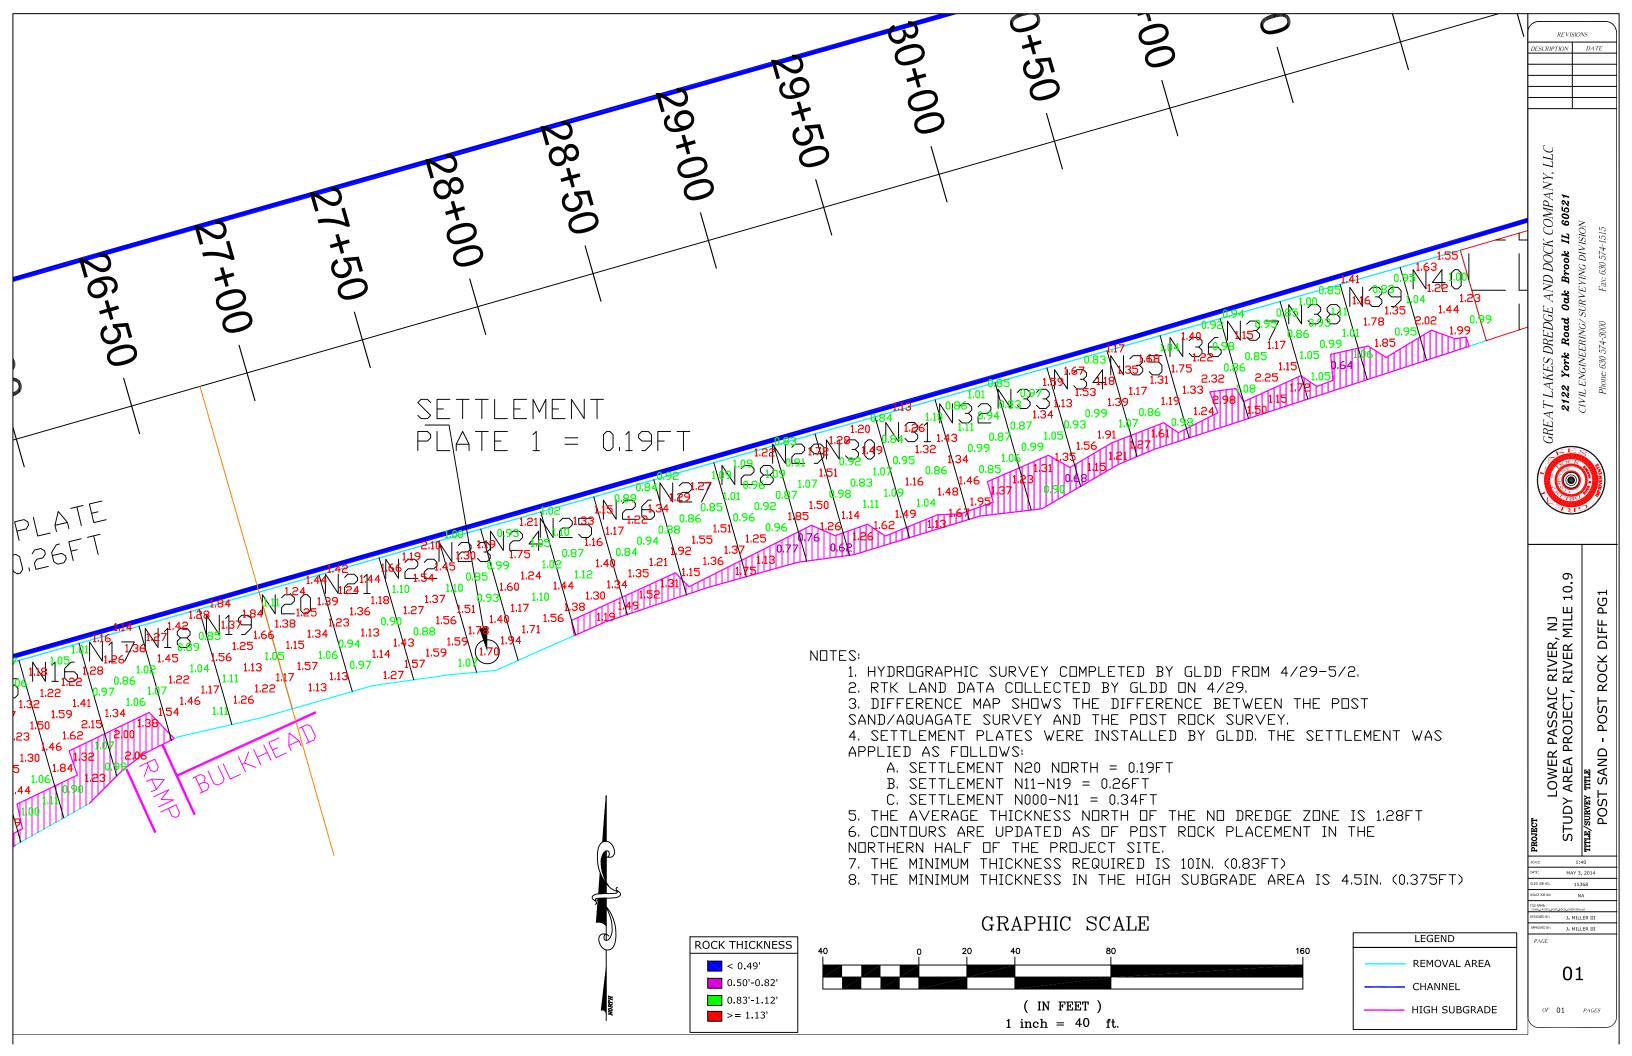
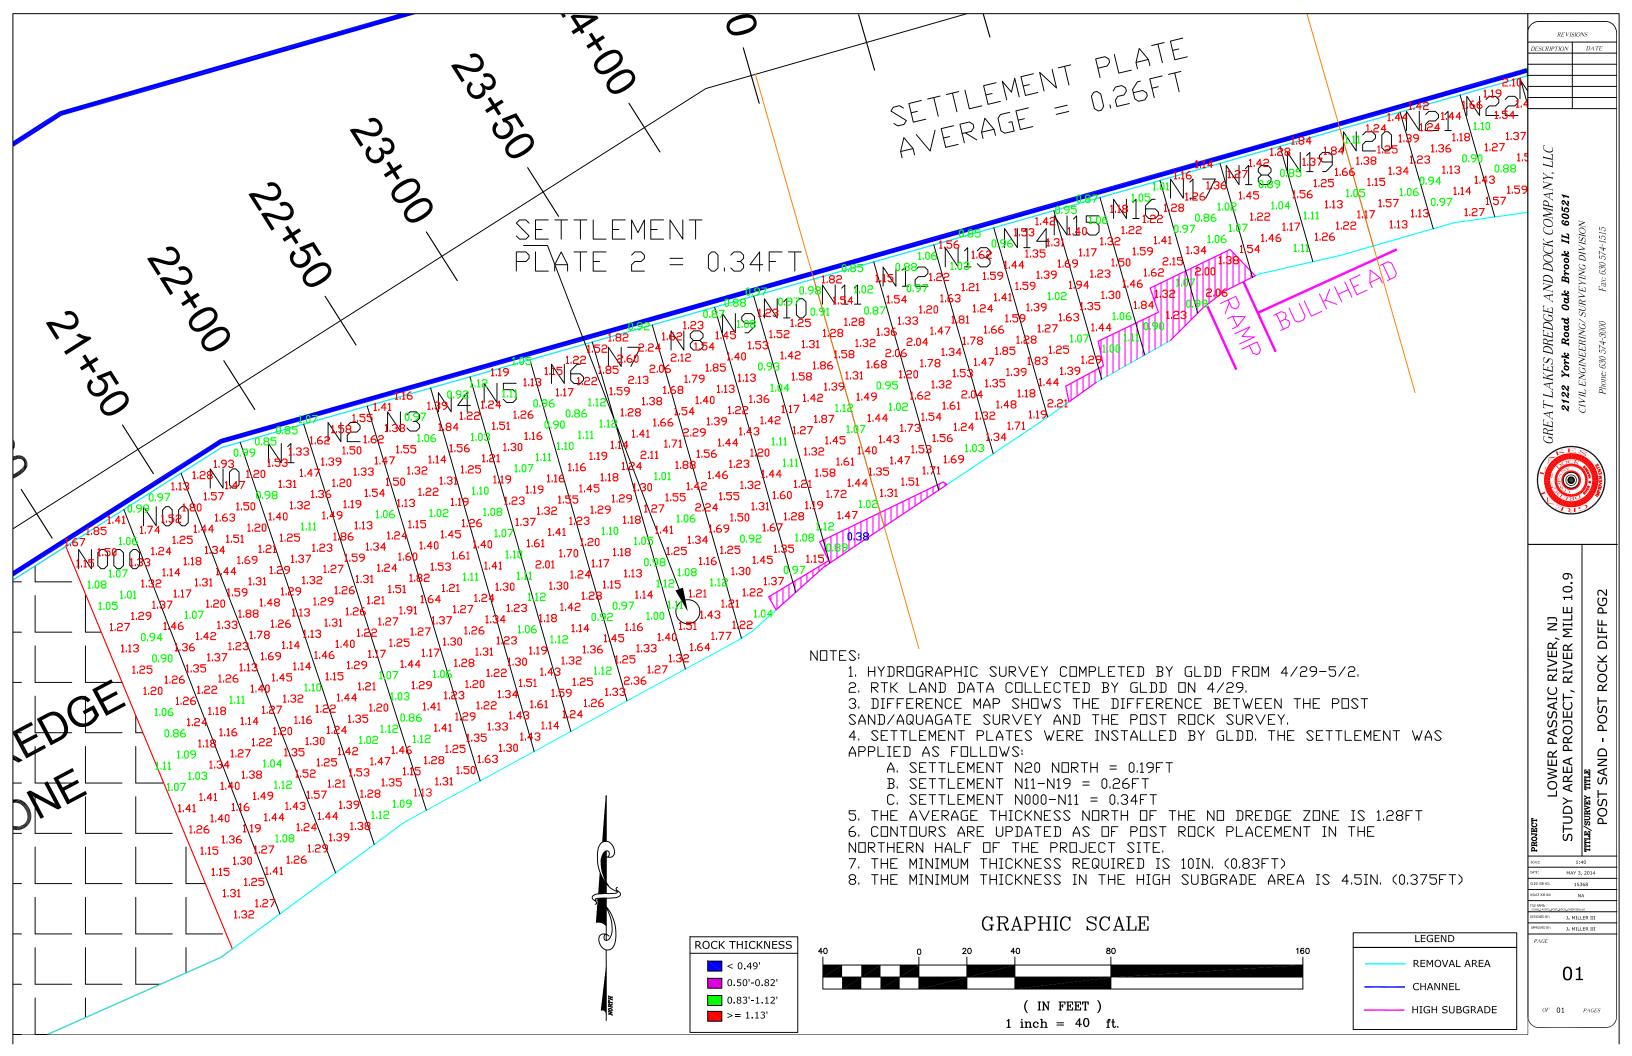
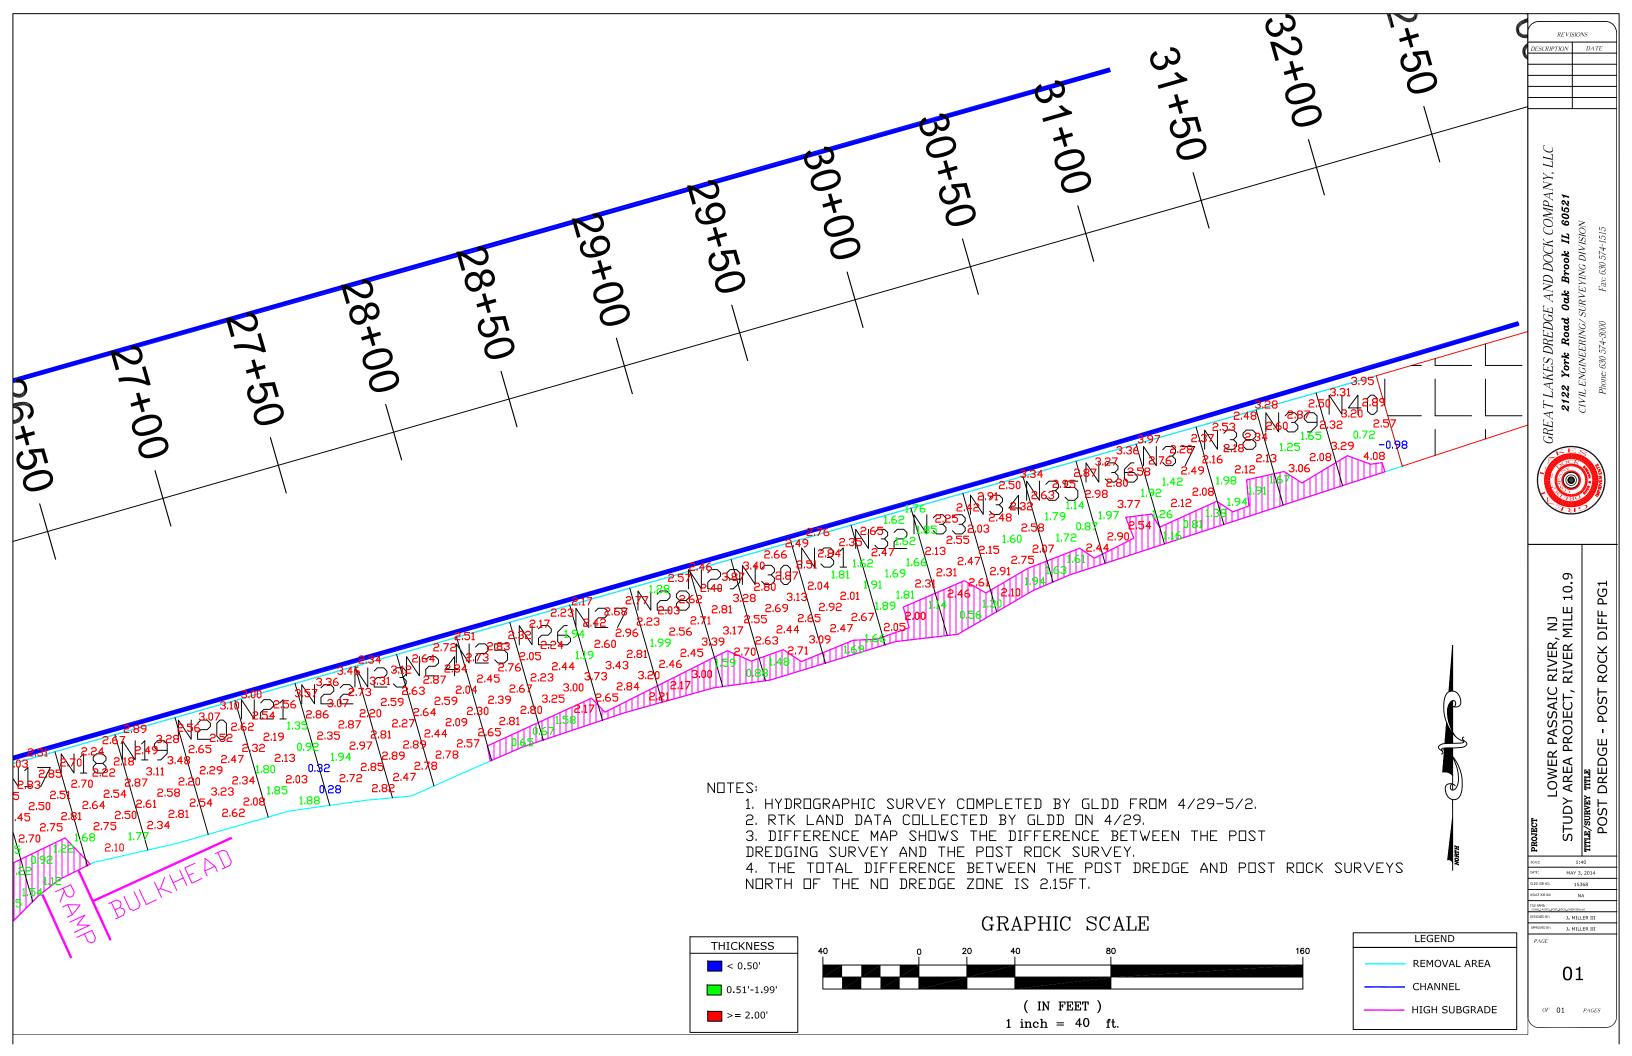
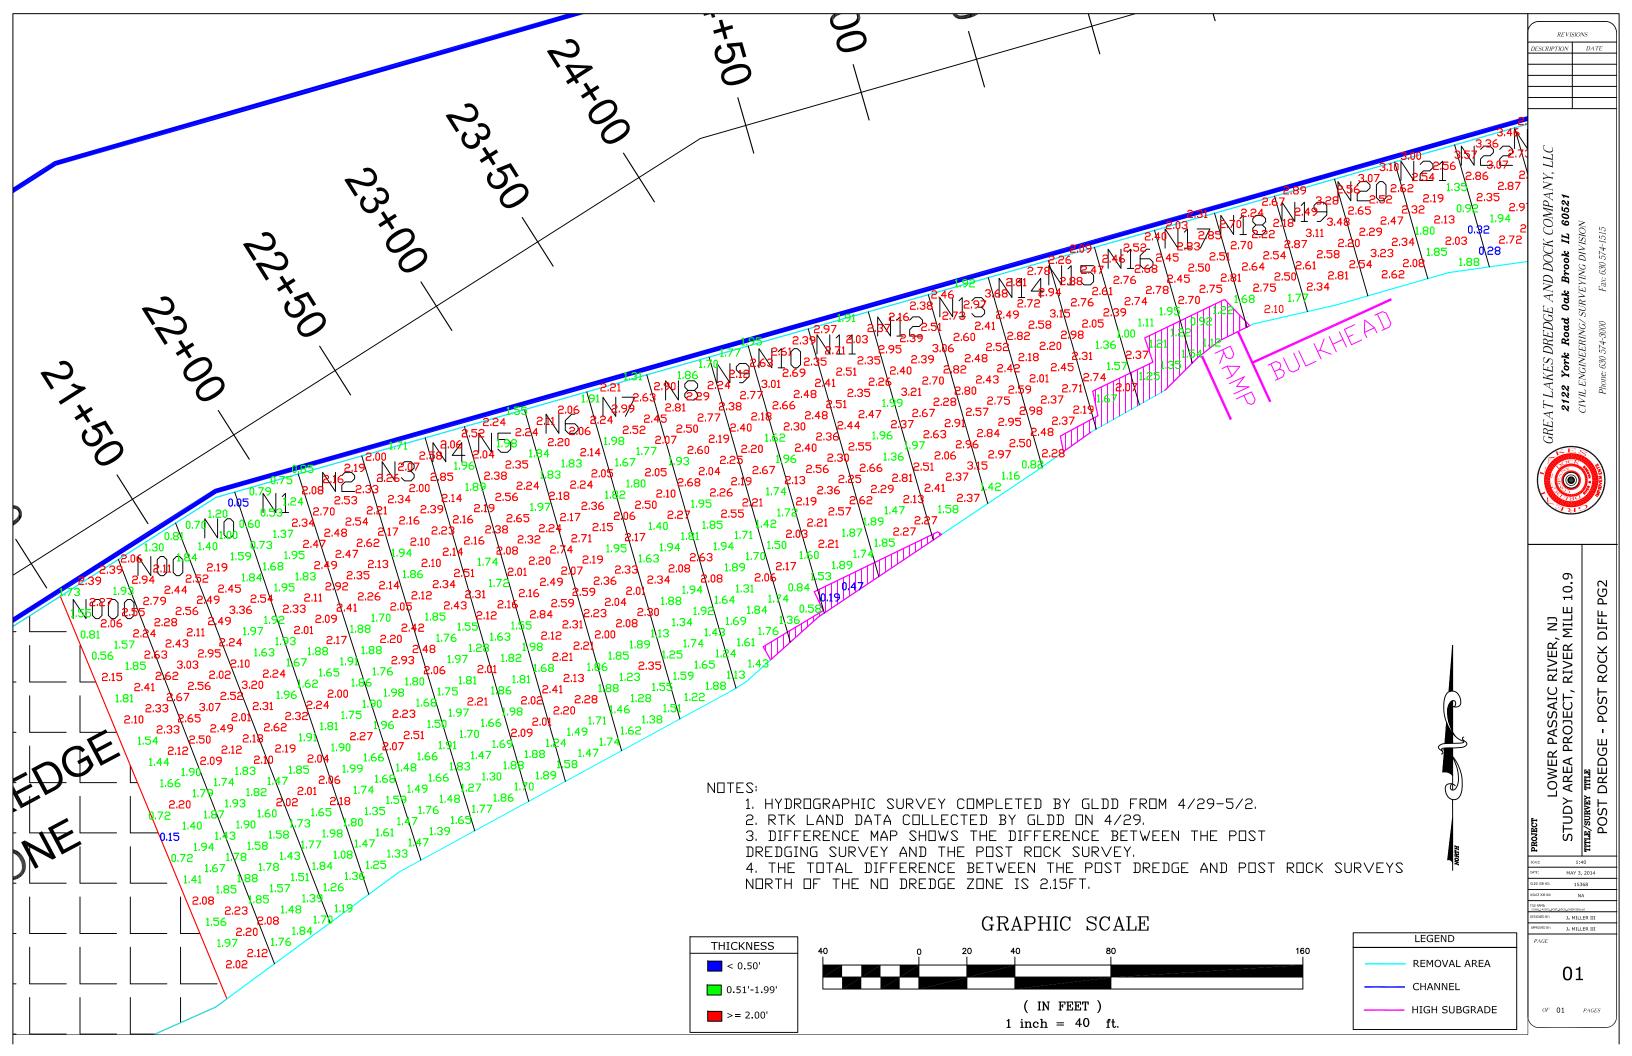
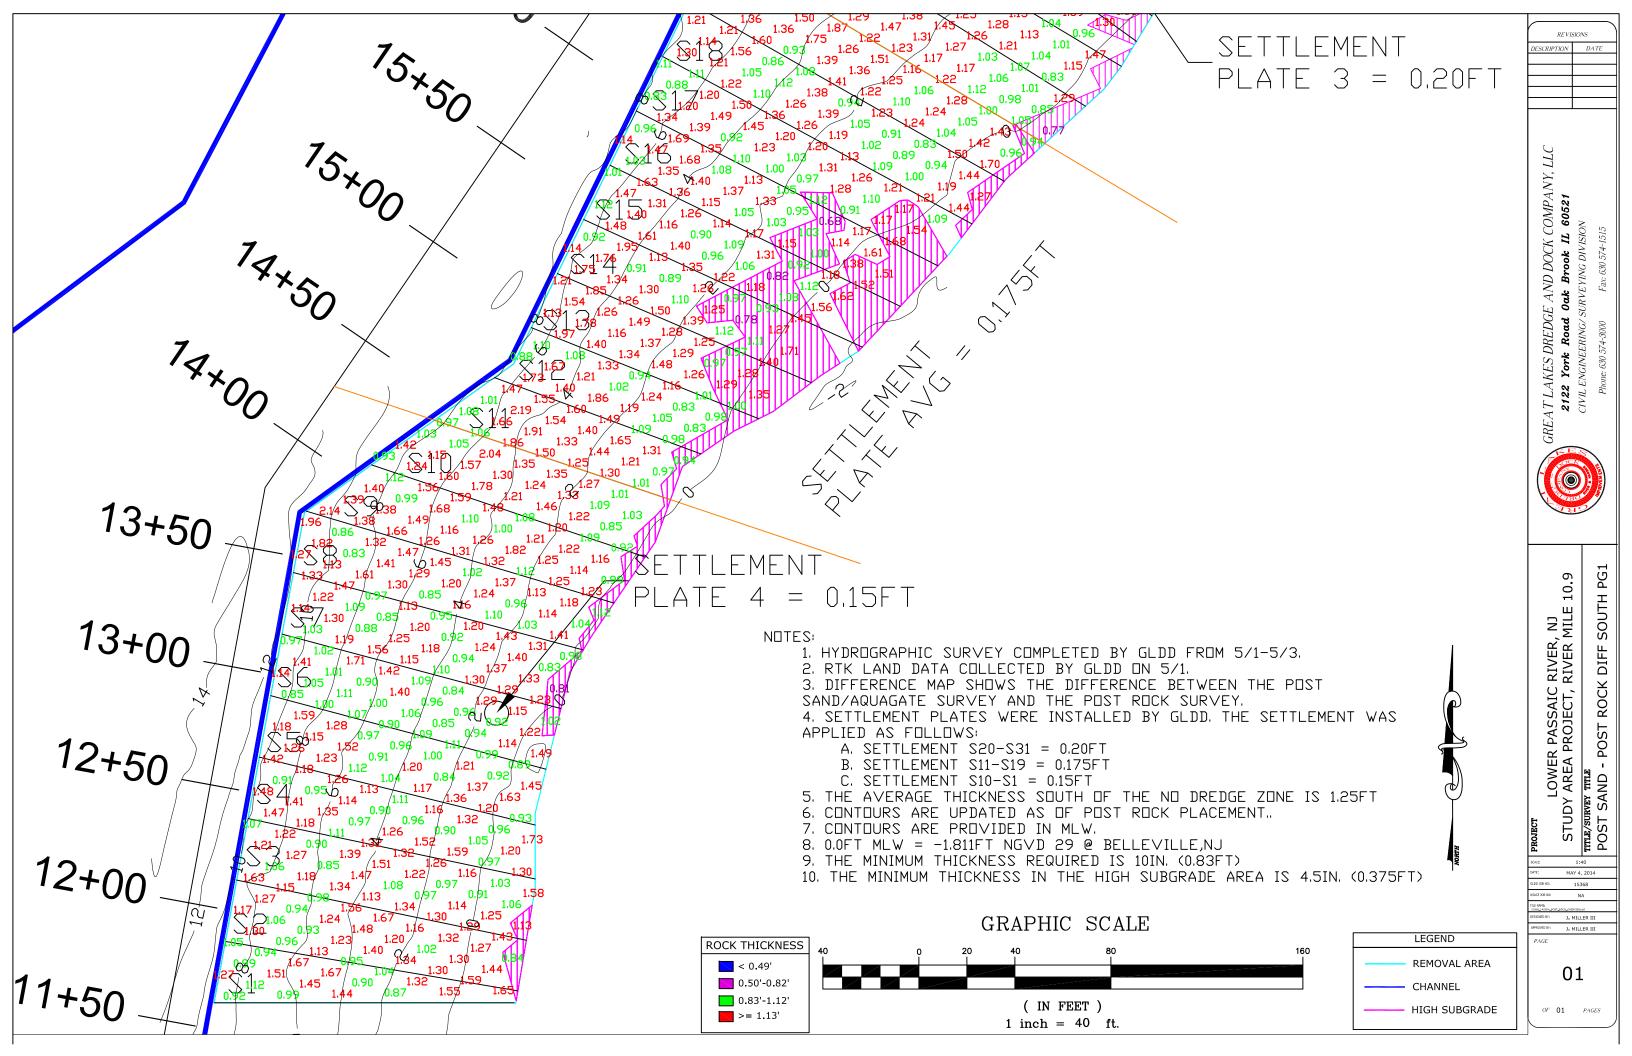
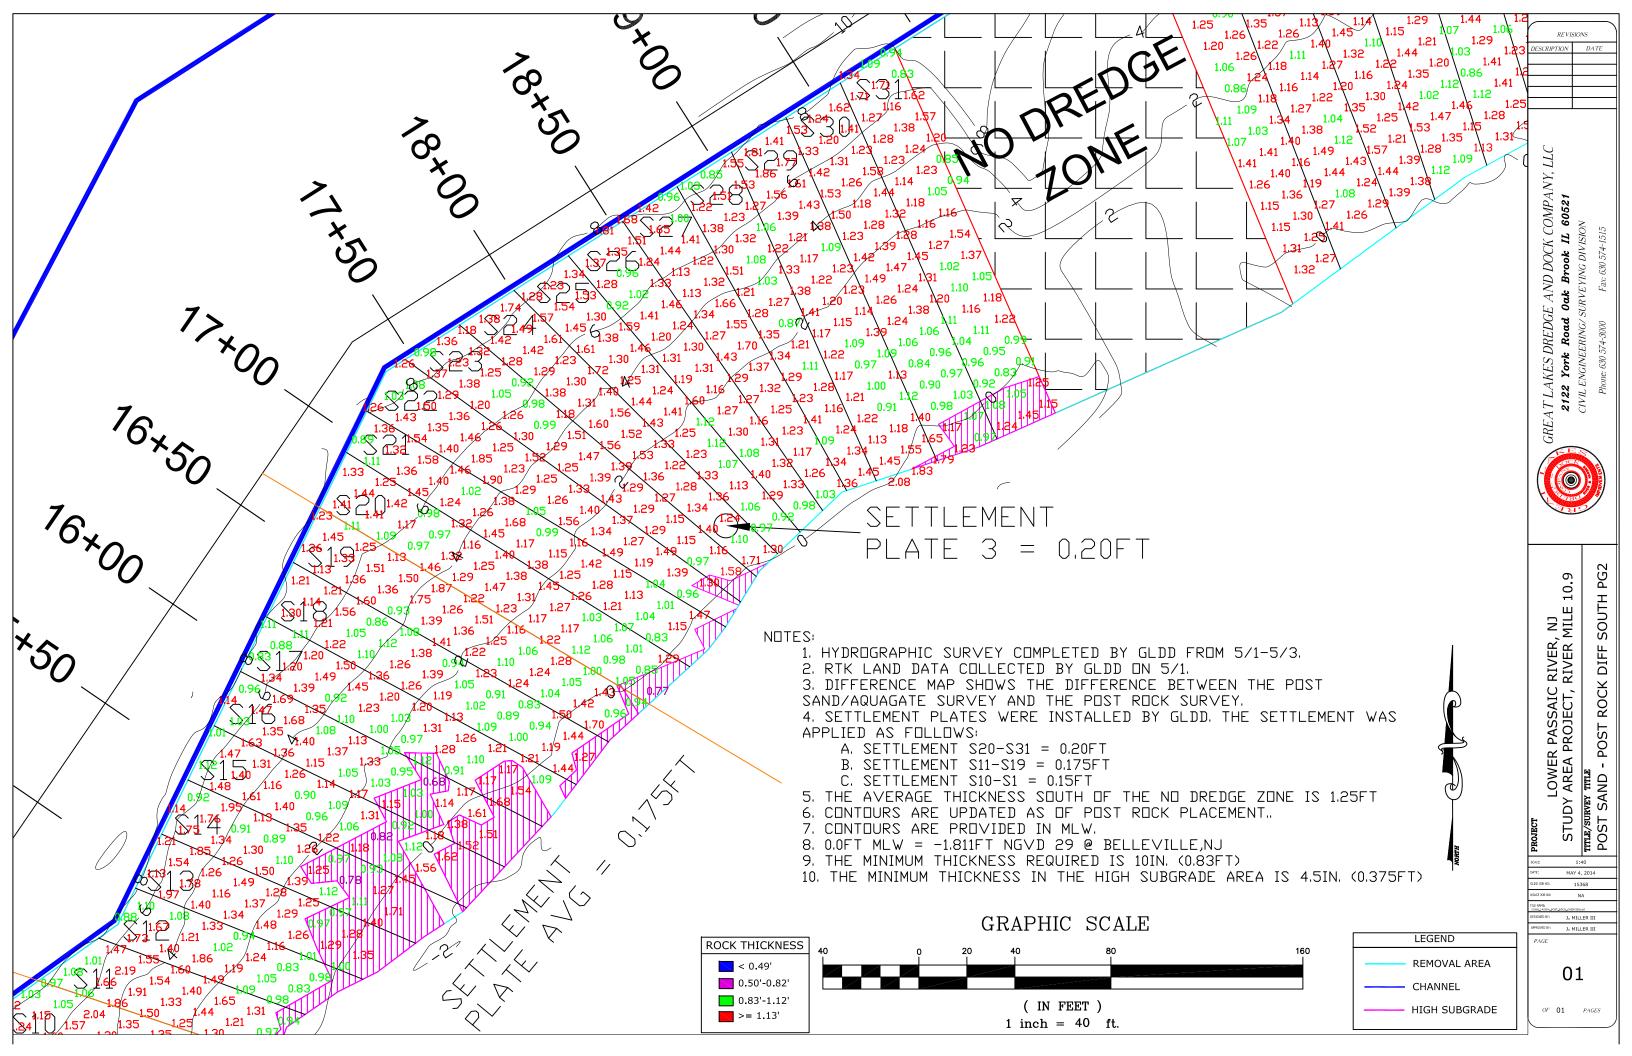
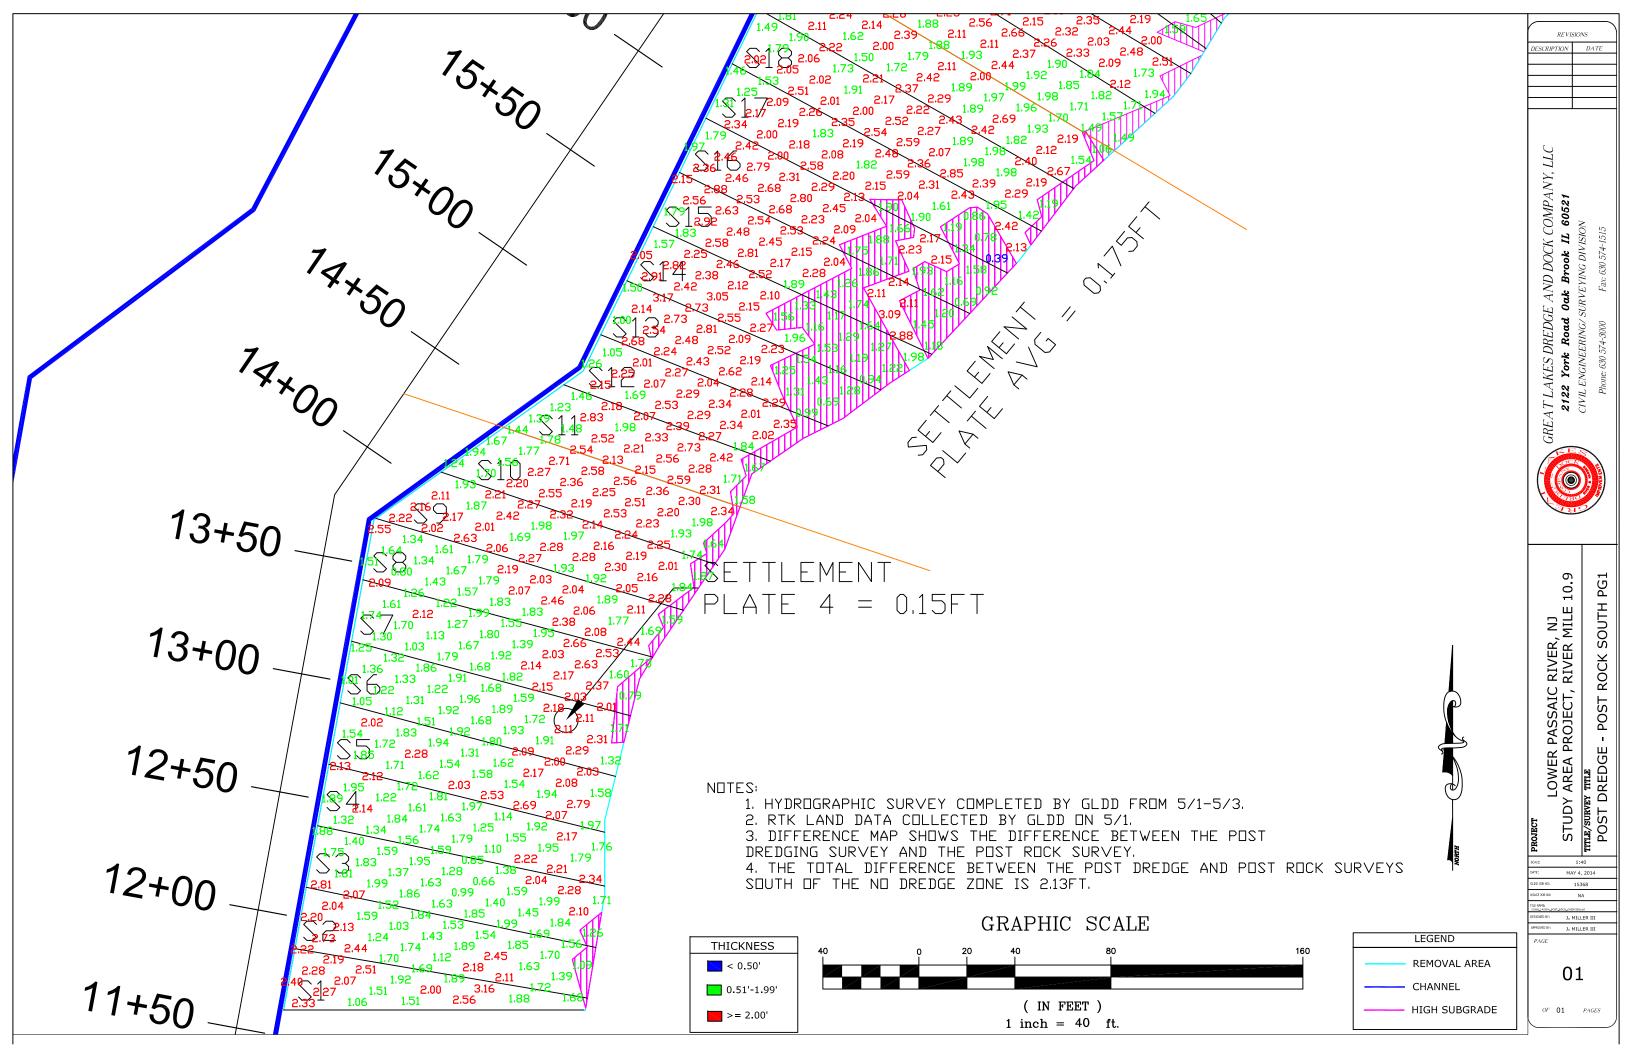
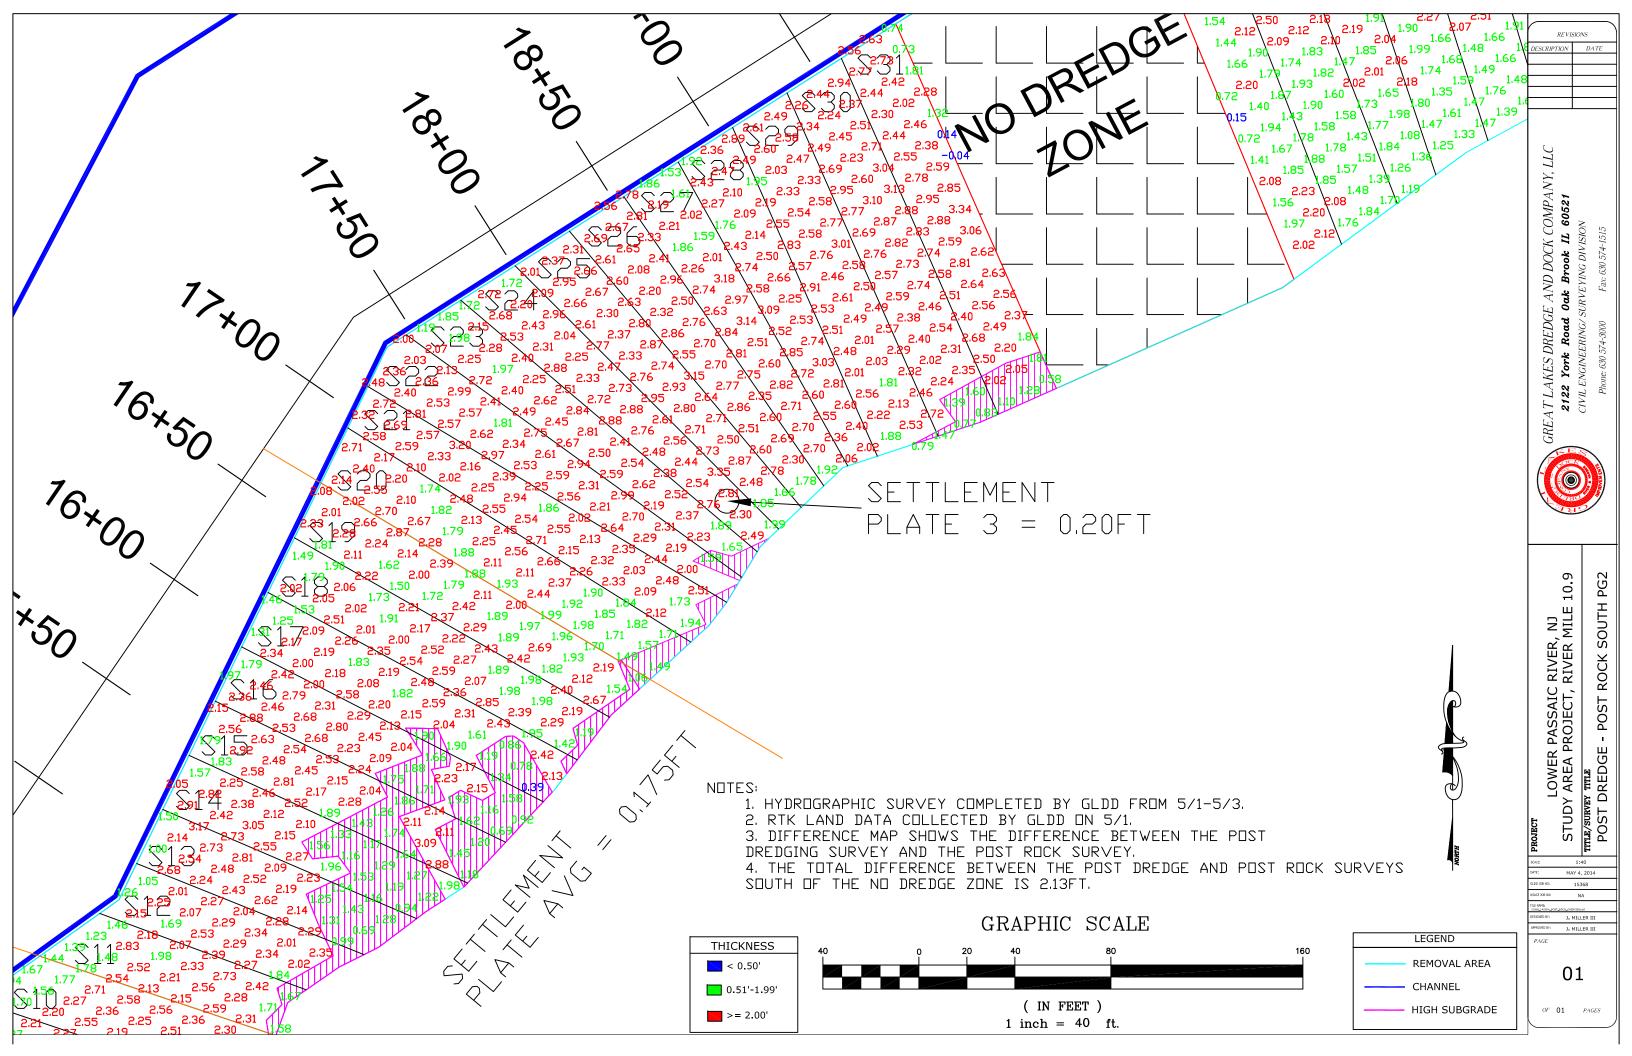
Attachment #1 Armor Stone Thickness Surveys

The final bathymetric surveys for the armor rock layer were conducted April 29 through May 3, 2014. This data was compared to the surveys conducted after the active layer was placed in order to determine the thickness of the armor stone layer. The results of this comparison demonstrate that the minimum thickness of 10 inches (4.5 inches for modified cap areas) was achieved in all areas and the average thickness of the armor stone is 1.27 feet (15.2 inches). These comparison surveys are provided as Attachment #1.

The bathymetric surveys indicate that the minimum thickness of armor stone (4.5 or 10 inches) has been placed in accordance with the requirements of the technical specifications. However, the

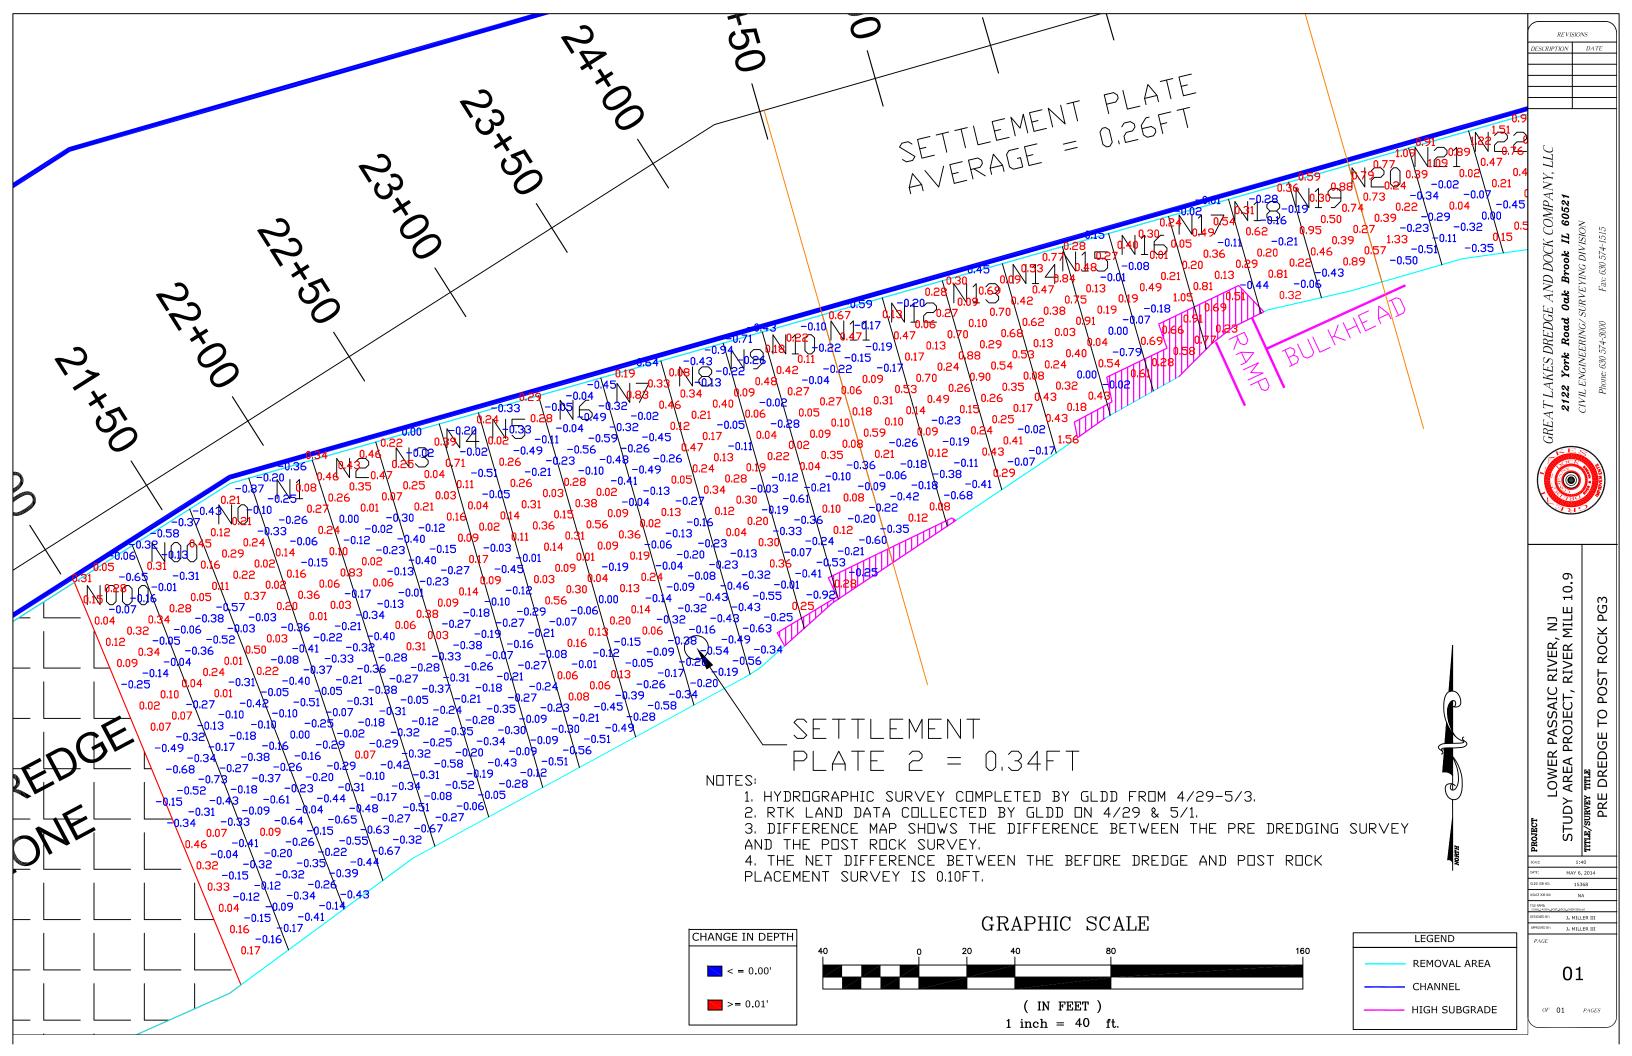
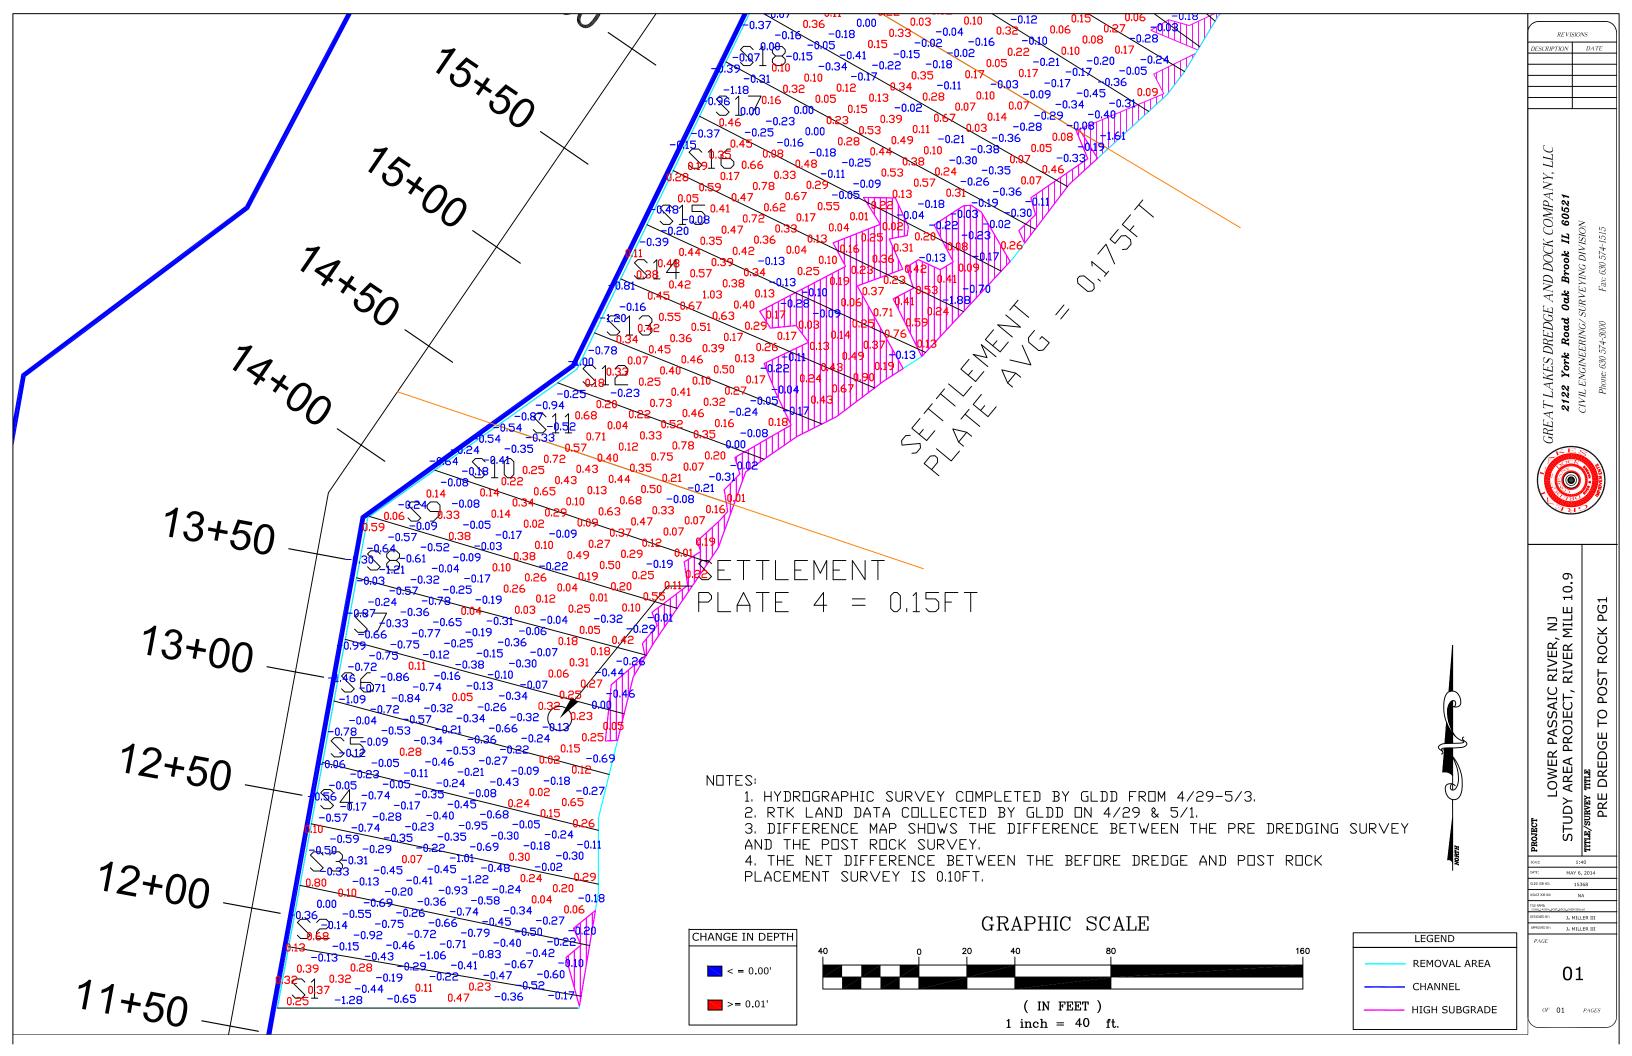
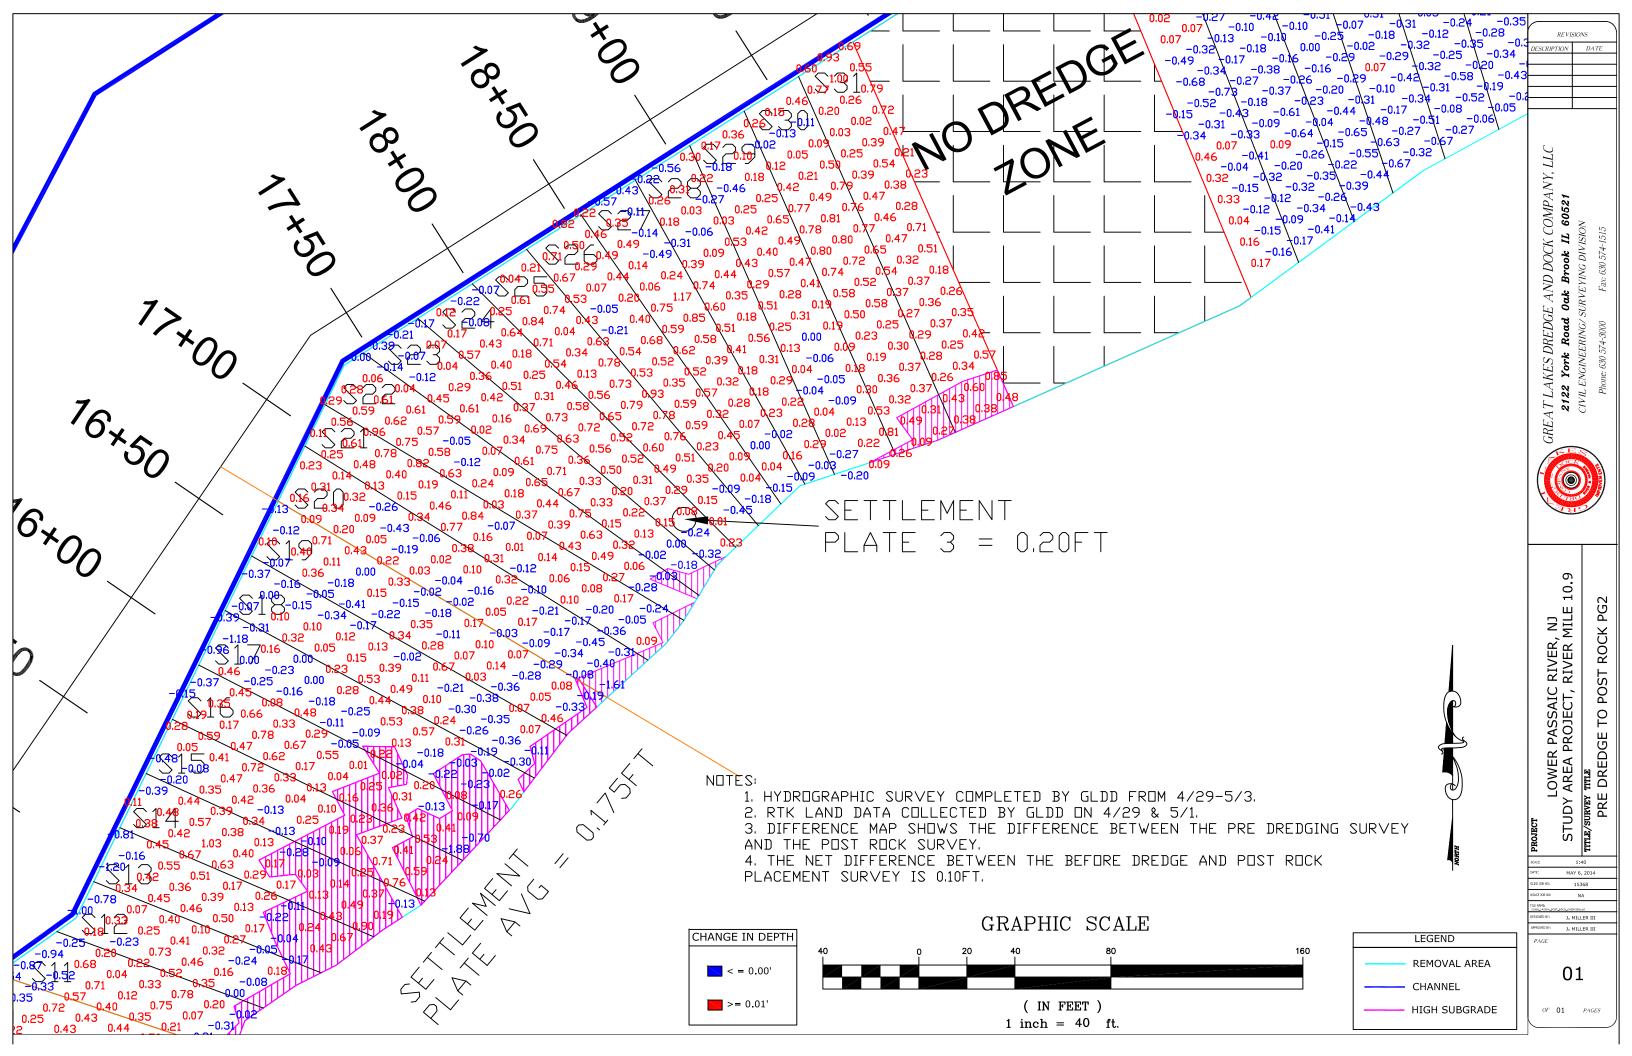
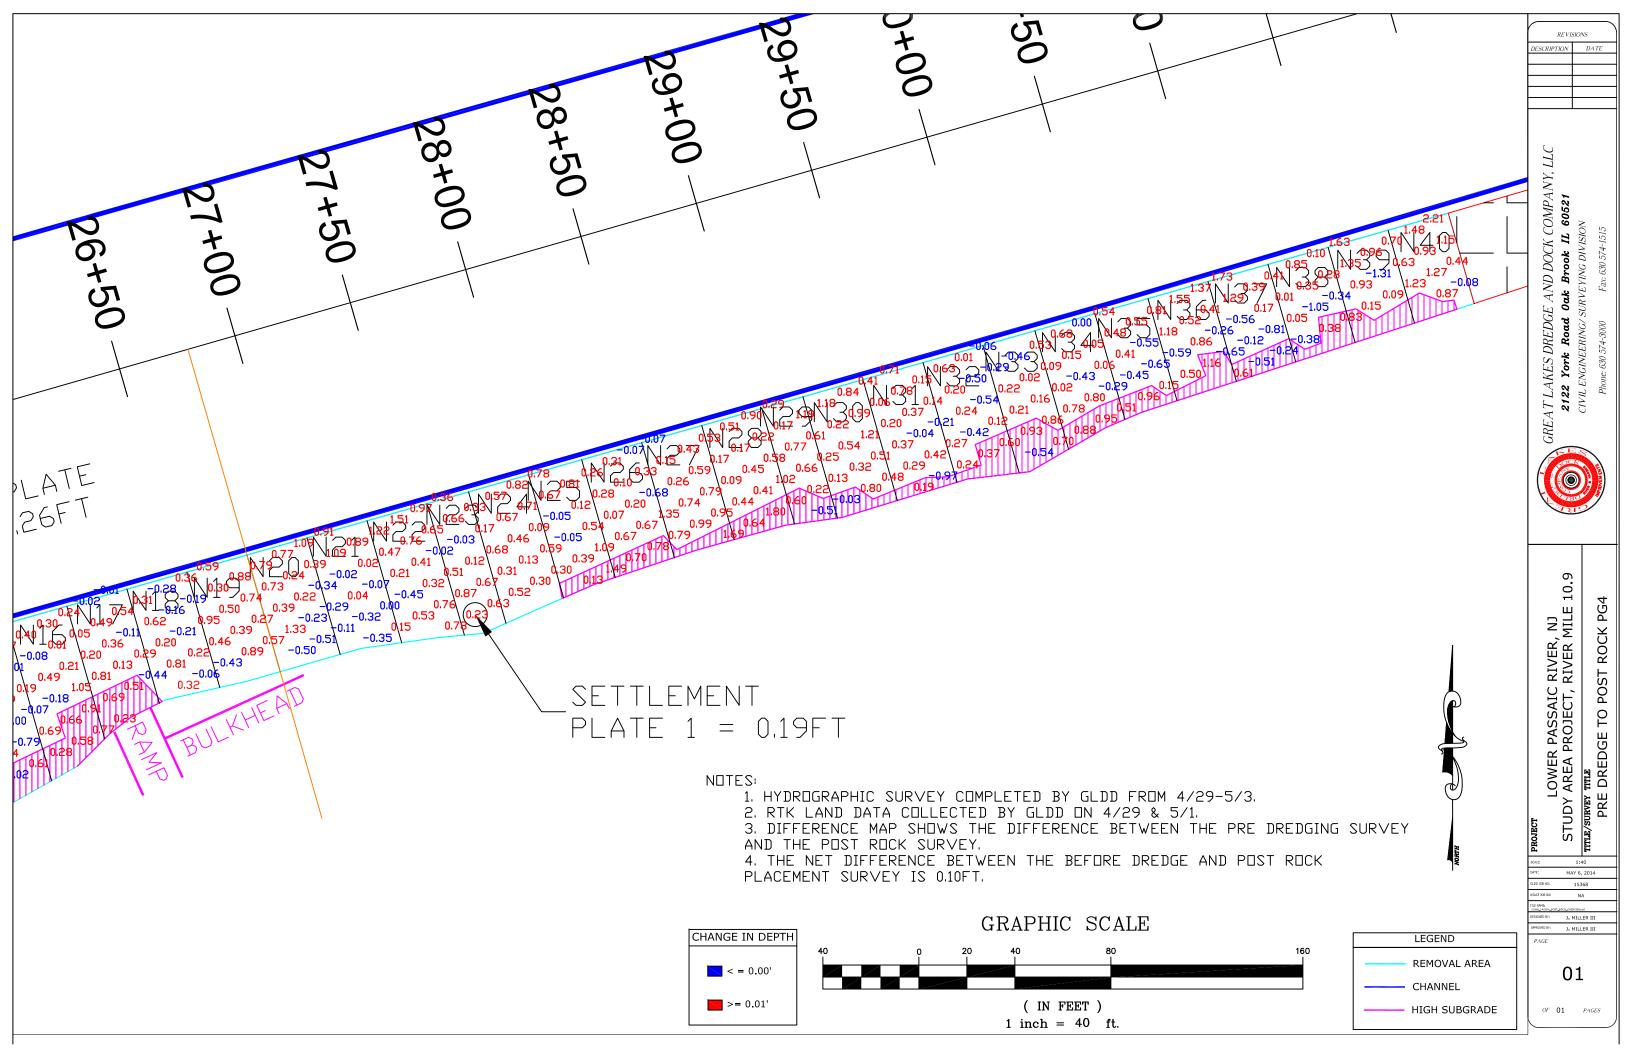
Attachment #2

The technical specification required a maximum average thickness of 24 inches in order to ensure that the final cap elevation did not exceed the pre-dredge surface elevations. A comparison of the pre-dredge surface to the final armor stone elevations indicates that the cap is an average of 1.2 inches greater than the pre-dredge surface. The results of this comparison are provided as Attachment #2.

Comparison of Pre-Dredge and Post Armor Stone Surveys

average thickness of the cap was determined to be an average of 25.7 inches which exceeds the allowable maximum average thickness of 24 inches. The purpose of the 24 inch maximum thickness requirement was to minimize the potential for the final average cap elevation to exceed the predredge sediment surface. However, when the armor stone elevation is compared to the predredge surface elevation the cap only exceeds the pre-dredge surface by an average of approximately 1.2 inches.

While the armor stone surface is slightly higher than the pre-dredge surface, the final elevation is considered acceptable and no further actions are required for the following reasons:
